UNDERWATER BRIDGE INSPECTION REPORT

STRUCTURE NO. R0156
PEDESTRIAN WALKWAY
OVER THE
PELICAN RIVER (MILL POND)
DISTRICT 4 - OTTER TAIL COUNTY

PREPARED FOR THE
MINNESOTA DEPARTMENT OF TRANSPORTATION
BY
COLLINS ENGINEERS, INC.
JOB NO. 3512 (CEI 14A)

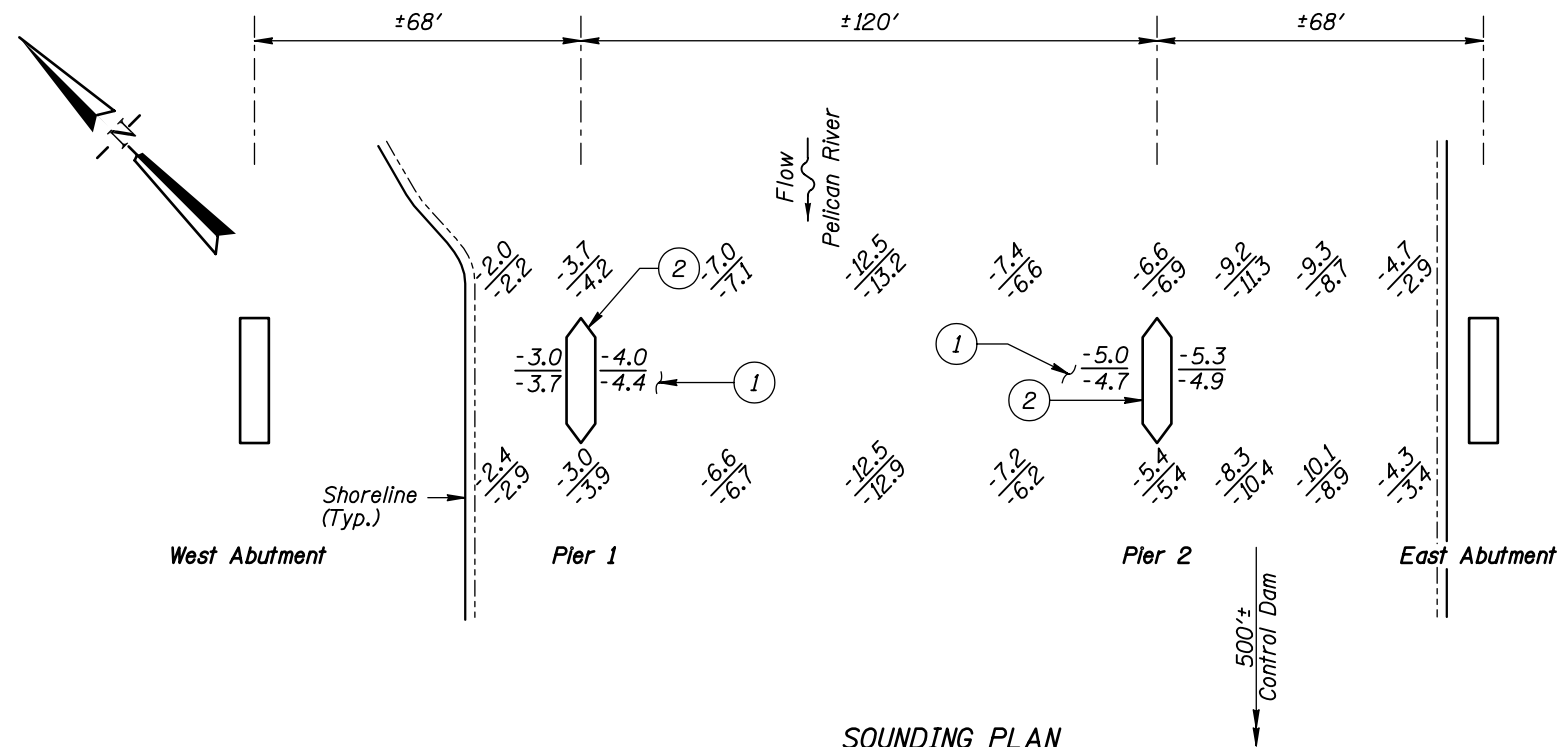
INSPECTION AND SOUNDING PLAN

- ① The channel bottom consisted of a firm sandy gravel and silt with up to 2 inches of probe rod penetration.
- ② The concrete of both piers was in good and sound condition and exhibited only random concrete popouts, up to 1 inch in diameter, on all surfaces.

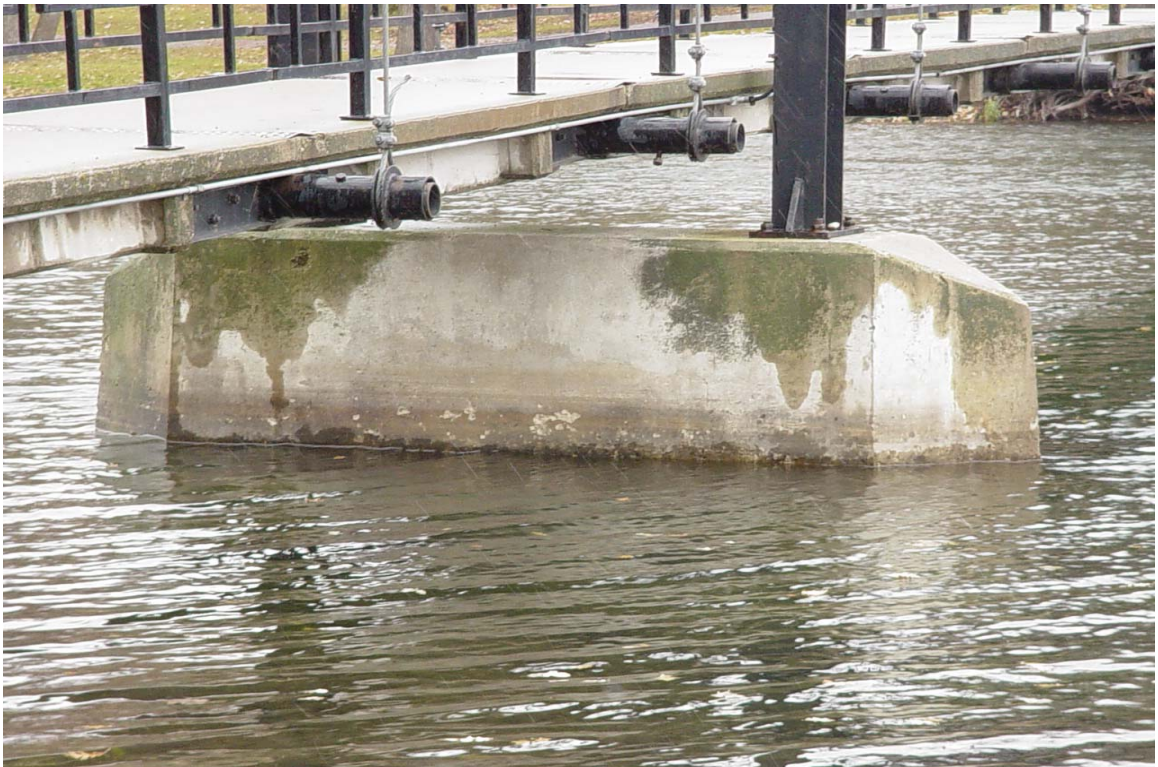
- (A) The concrete of the piers was in good and sound condition below water with only minor, 1 inch maximum diameter, concrete popouts observed in random locations along all faces.

Photograph 2. View of Pier 1, Looking South.

- (A) Reinspect the submerged substructure units at the normal maximum recommended (NBIS) interval of five (5) years.

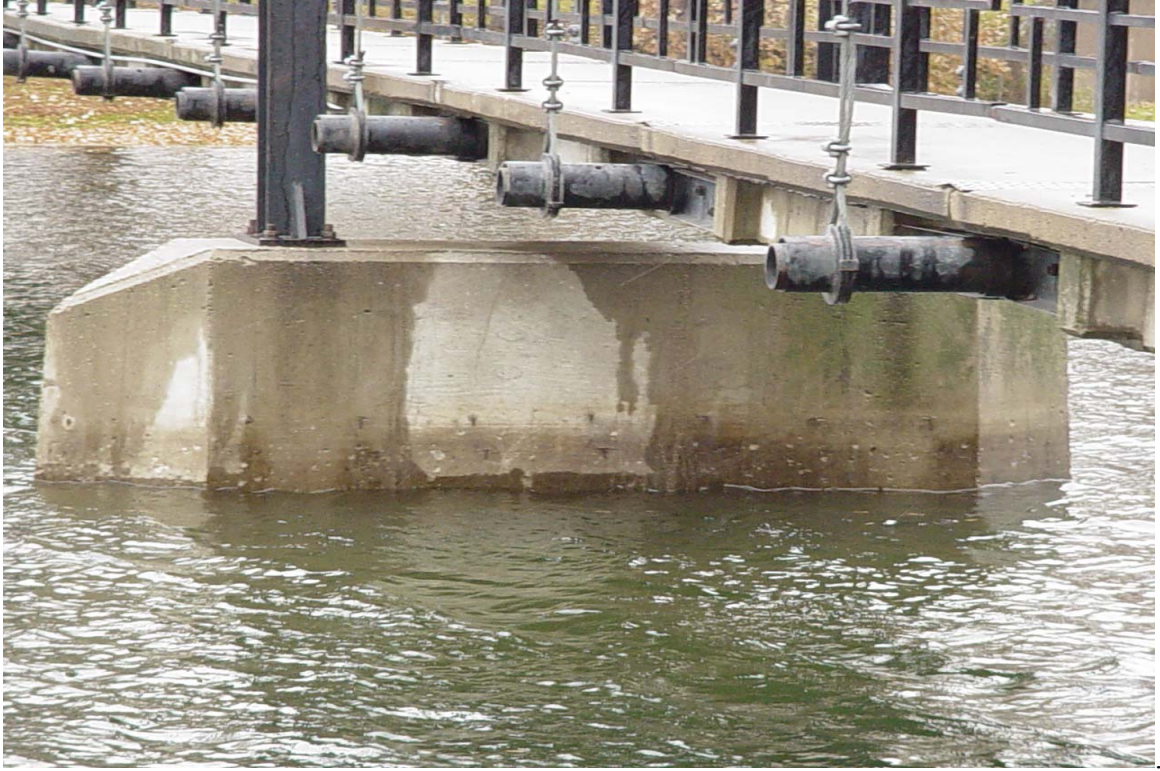
Photograph 3. View of Pier 2, Looking North.
